Testing of Shelter Design and Industrial Hardening Concepts at the Mill Race Event

FINAL REPORT

Contract No. EMW-C-0611
Work Unit 1128D

SCIENTIFIC SERVICE, INC.

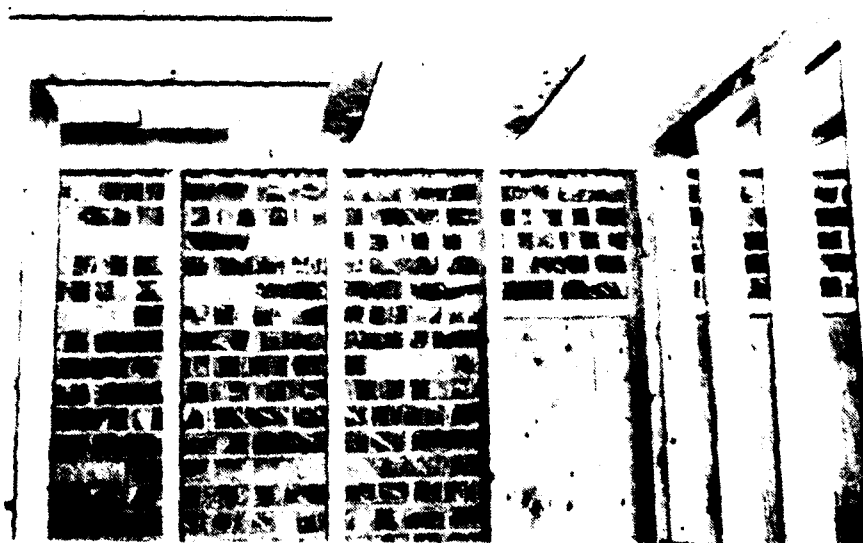
Six days after the test, one end wall of the building was cleared of earth and a door exposed. Figure 3-12 shows this exposed end wall with the door closure partially removed. An examination of the interior of the building did not indicate any structural distress in the building or the shores. No cracks were noted in either the brick or block walls, or in the concrete slab ceiling. The interior was clean and free of debris. Figure 3-13 is an interior view of the building after test, showing the ceiling slabs, wall bracing, and stud wall shoring.

Fig. 3-13. Interior View of Building, Posttest.

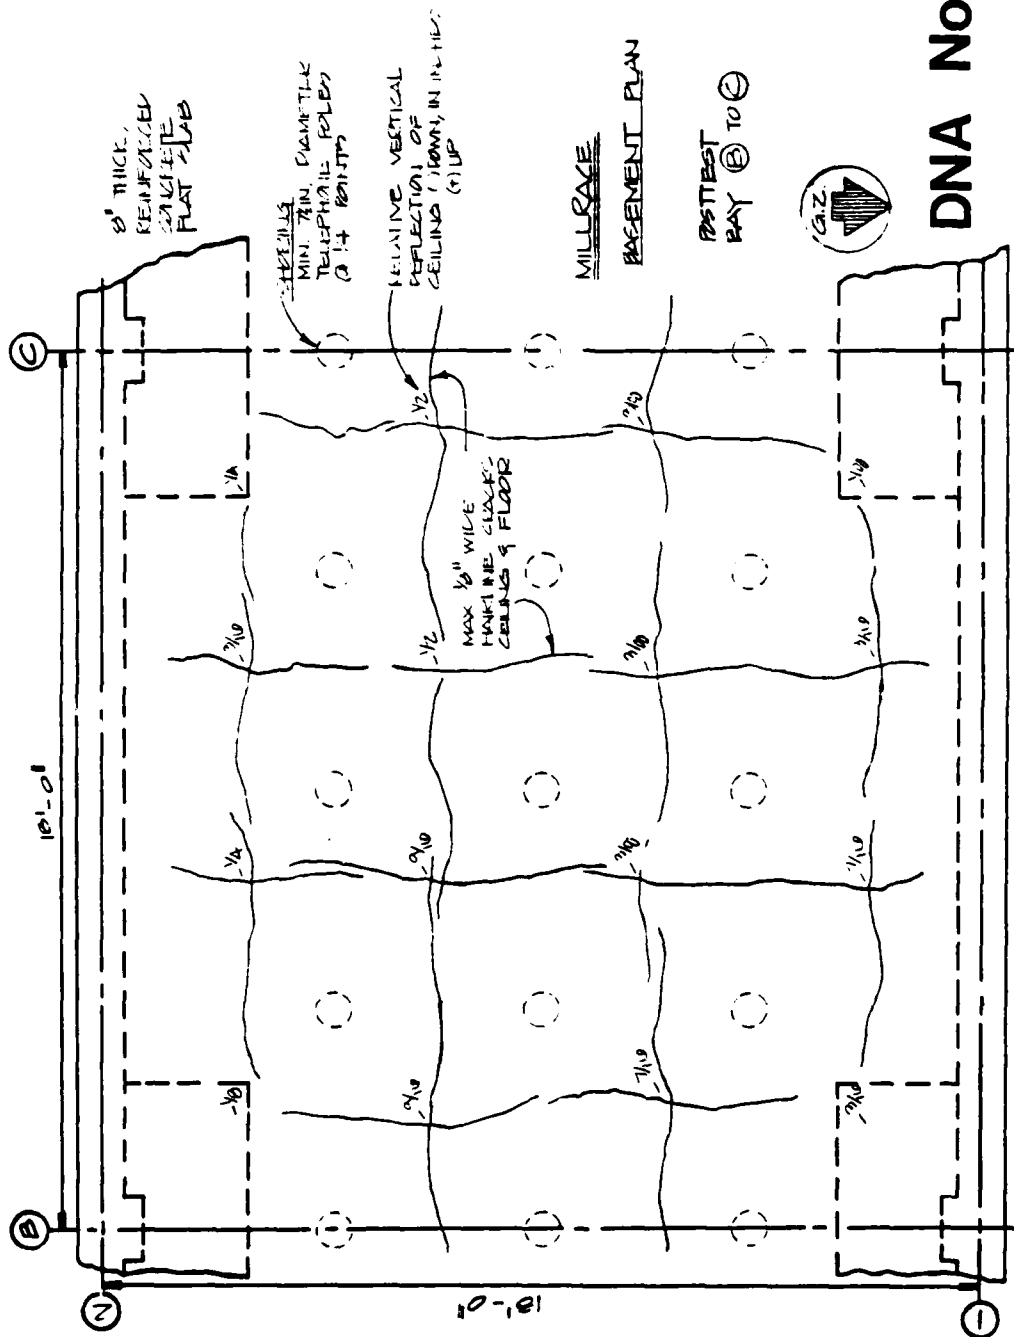
Both the floor and ceiling slabs in all three bays exhibited cracking in both directions midway between the shoring. The maximum vertical deflection of the ceiling in these bays was $5/8$ in. in a downward direction. Figures 5-28, 5-29, and 5-30 show the location of the cracks and the recorded ceiling deflections. Figure 5-31 is an interior view of these three bays looking toward line A from line C, and shows the timber pole shores in the foreground, and one of the steel tube shores in the background. Figure 5-32 is a closeup of the steel tube shores, and shows a load cell in location on top of the shore.

Fig. 5-29. Location of Shoring and Damage to Floor and Ceiling Slabs, Bay B to C, Area No. 1.

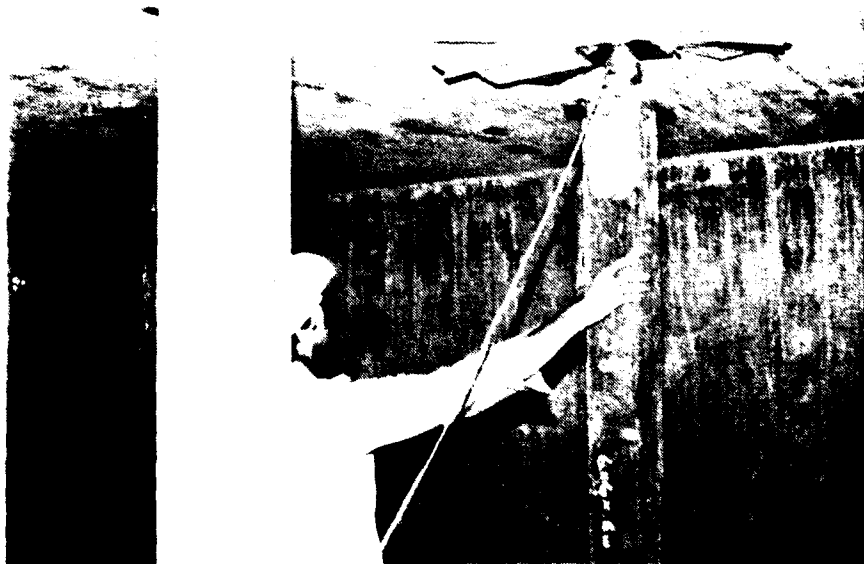
Fig. 5-32. Closeup of Steel Tube Shores, Area No. 1.

The load cell, located as shown in Figure 5-28, indicated a loading of 505 kips, with a loading duration of 50 ms.

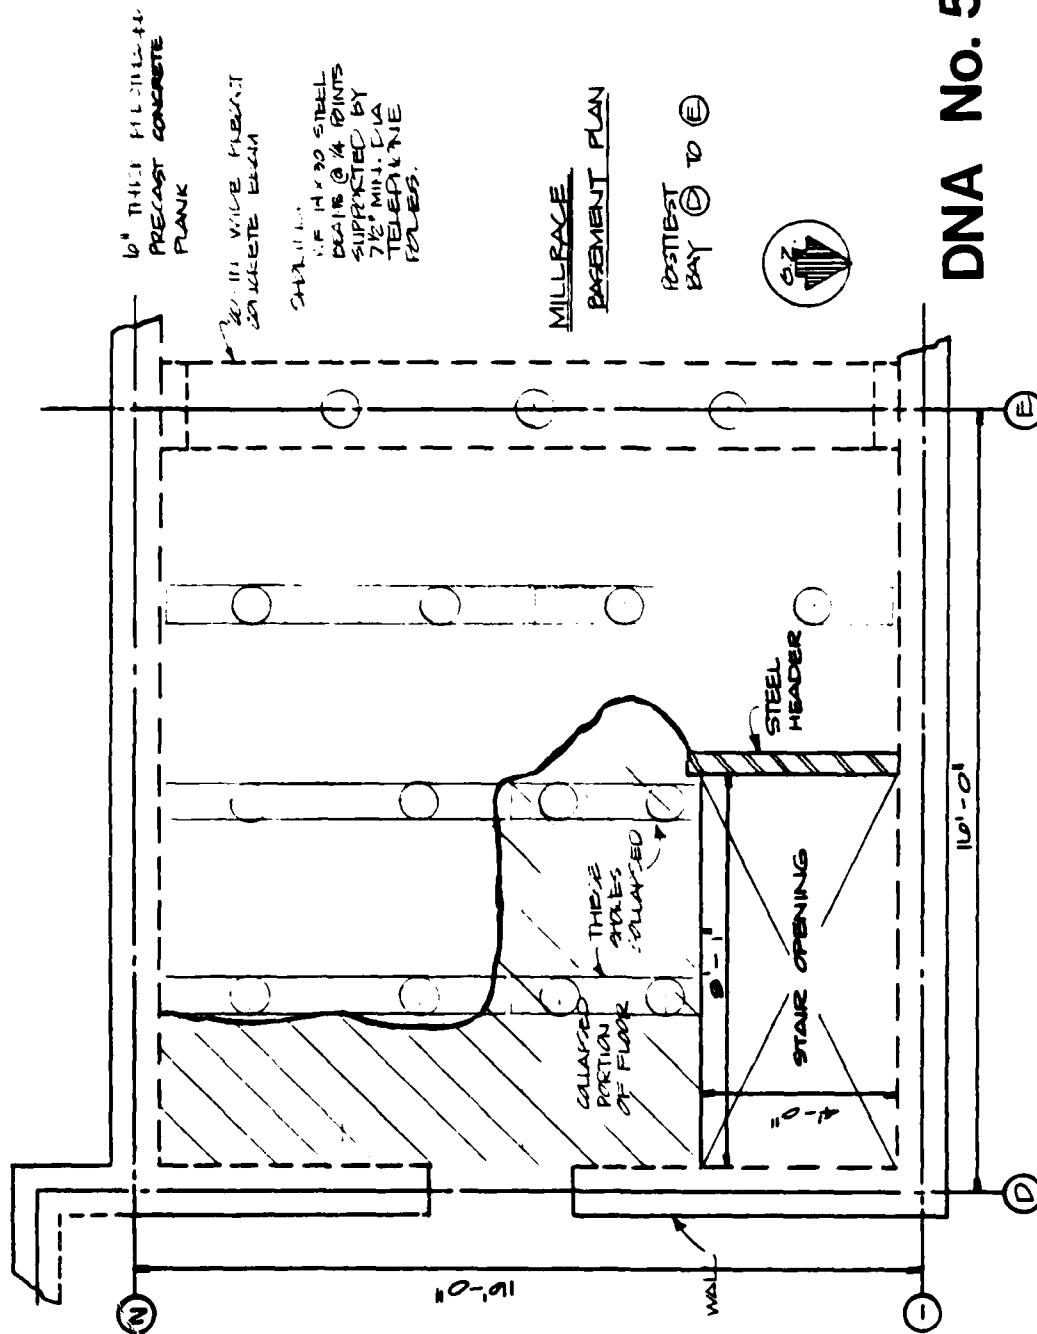
In the bay from lines D to E (Figures 5-1, 5-5, and 5-19), where the floor above was constructed of prestressed precast concrete plank and shored at the one-quarter points, approximately one quarter of the floor collapsed. This collapse occurred adjacent to the stairwell and along line D, as shown in Figure 5-33. The remainder of the planks forming the floor above were badly cracked in the transverse direction at locations of support, both at the shores and at the beam/wall supports, but did not collapse. Figure 5-34 is a view looking at the stairs, and Figure 5-35 is a view looking down the stairwell. Both of these views show a number of timber poles on and around the stairs; some of these are from the stairwell closure, and some are shores that have been knocked down. Figure 5-36 shows the doorway through the wall at line D. The stairs, which were constructed of heavy dimension lumber, were still usable after test.

Fig. 5-33. Location of Shoring and Damage to Precast Plank Floor, Bay D to E, Area No. 2.

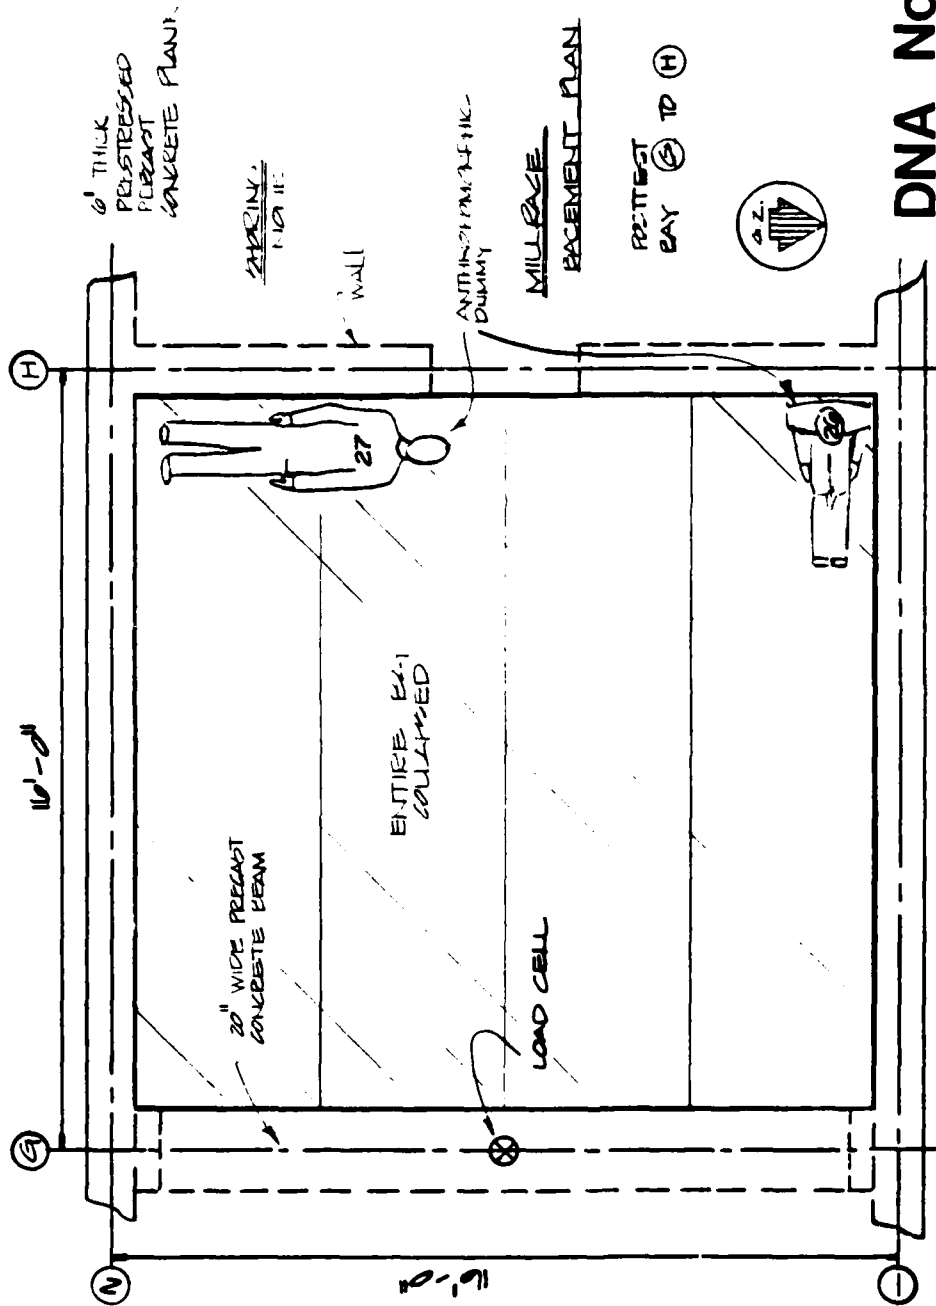
Fig. 5-44. Location of Instrumentation and Damage in Bay G to H, Area No. 3.

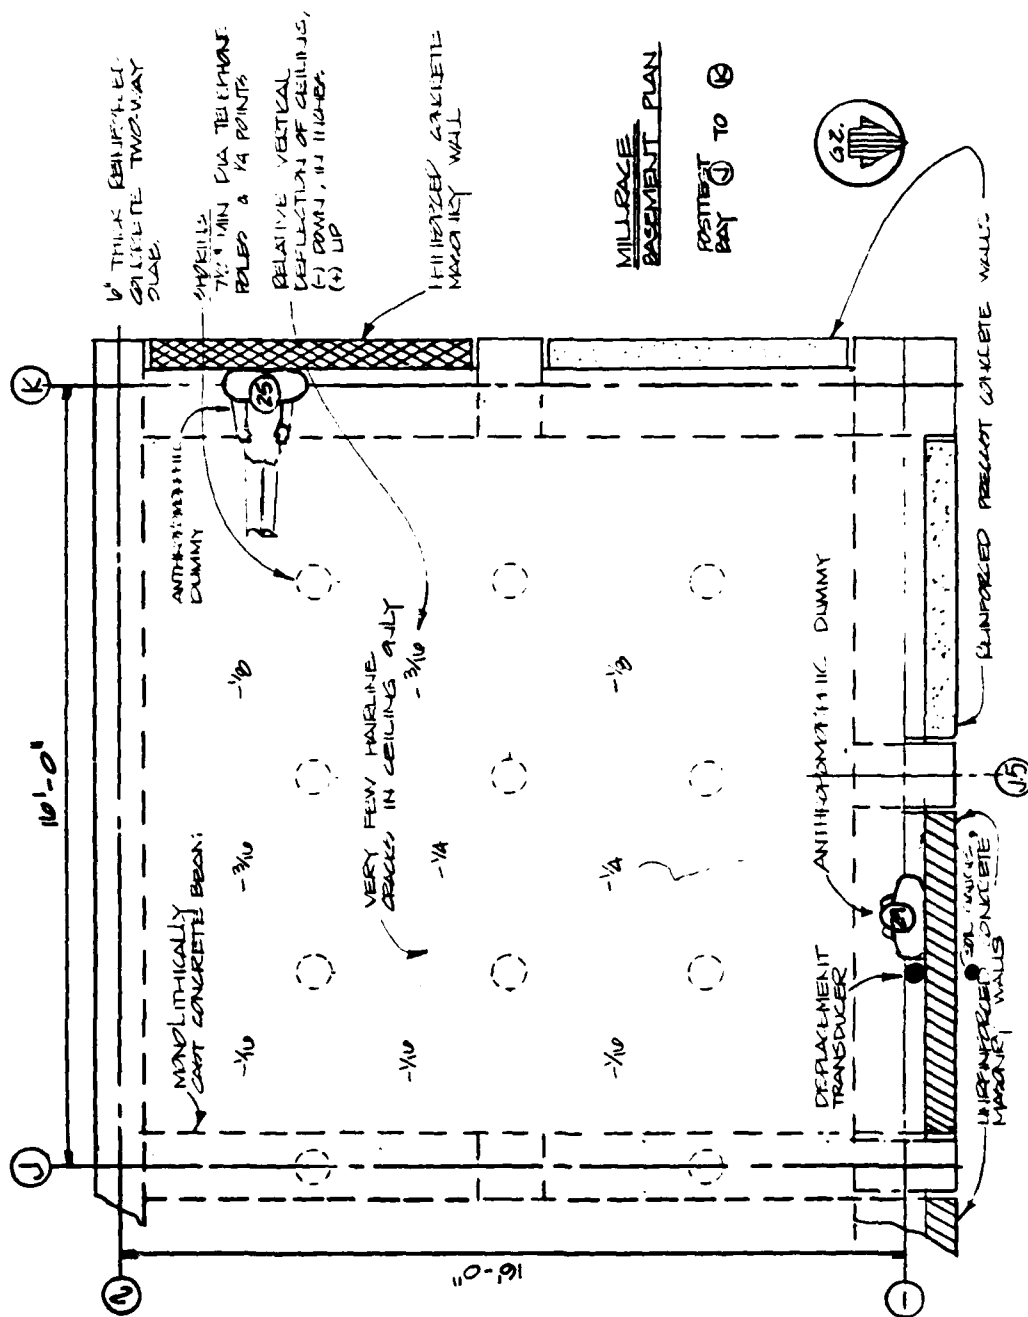
The two bays between lines H and K (Figure 5-1, 5-6, and 5-19), of 6-in. thick reinforced concrete two-way slab construction, sustained very little damage. Both bays were shored at the one-quarter points with timber telephone poles, and were expected to perform well in the 40 psi range. No cracks were found in the floor slabs in either bay, and only relatively short hairline width cracks were noted in the ceiling. The ceiling cracks ran in both directions, midway between the shores. Figures 5-48 and 5-49 show the locations of these cracks. The maximum vertical deflection found in the ceiling was 15/16 in. The deflections recorded for both bays are shown in Figures 5-48 and 5-49.

Fig. 5-49. Location of Shoring, Instrumentation, and Damage to Two-Way Slab, Bay J to K, Area No. 4.

The dummy that was standing against the wall along line 1 in bay J to K (see Figure 5-49 for location) is shown in Figure 5-54. The head on this dummy had moved 1 in. to the right and had fallen forward on the chest, the left foot had moved 0.5 in. to the left, and the right foot had moved 0.25 in. to the left. No damage had been sustained by the dummy. The reading on the accelerometer was 10 g.

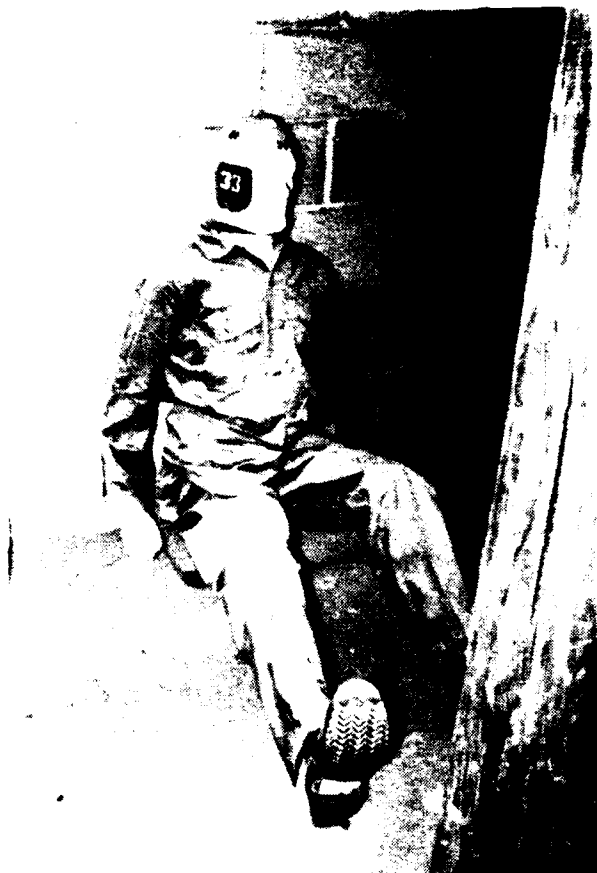
The three anthropomorphic dummies placed in the sitting position, two in bay H to J and one in bay J to K (33, 28, and 25), were all found in the pretest positions, sustained no damage, and no readings were recorded on their respective accelerometers. Figures 5-48 and 5-49 show the location of the dummies in each of the bays. All three of the dummies were covered moderately with dust that was assumed to have passed through the doorway, which was not closed, in the wall on line H during the failure of bay G to H. Figures 5-51, 5-52, and 5-53 show dummies (33) (28) and (25), respectively, after test.

Fig. 5-51. Dummy No. 33 After Test.

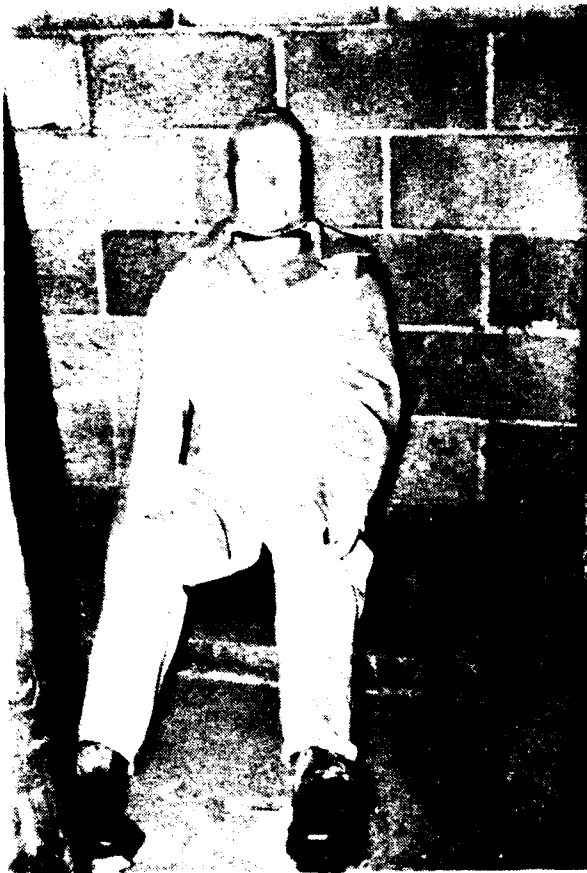
Fig. 5-53. Dummy No. 25 After Test.

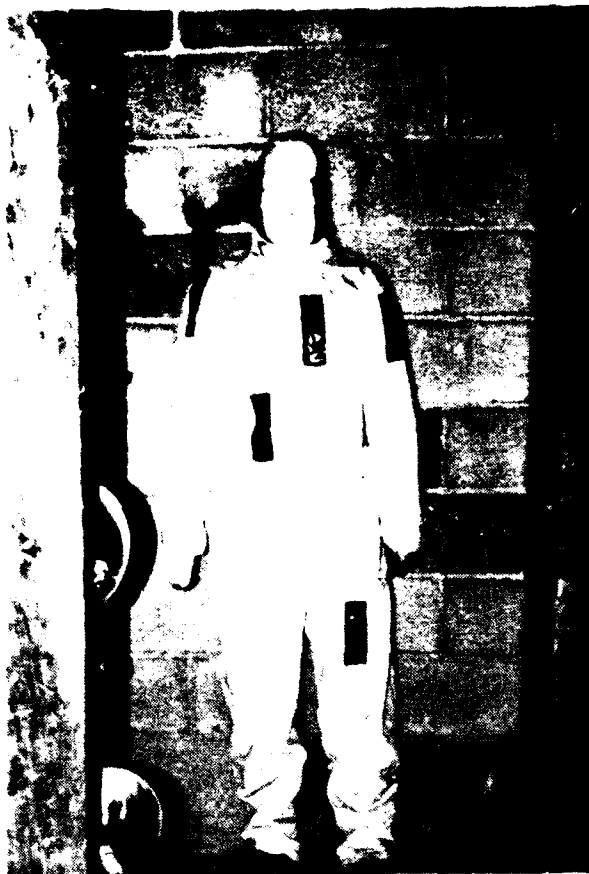
Fig. 5-54. Dummy No. 29 After Test.

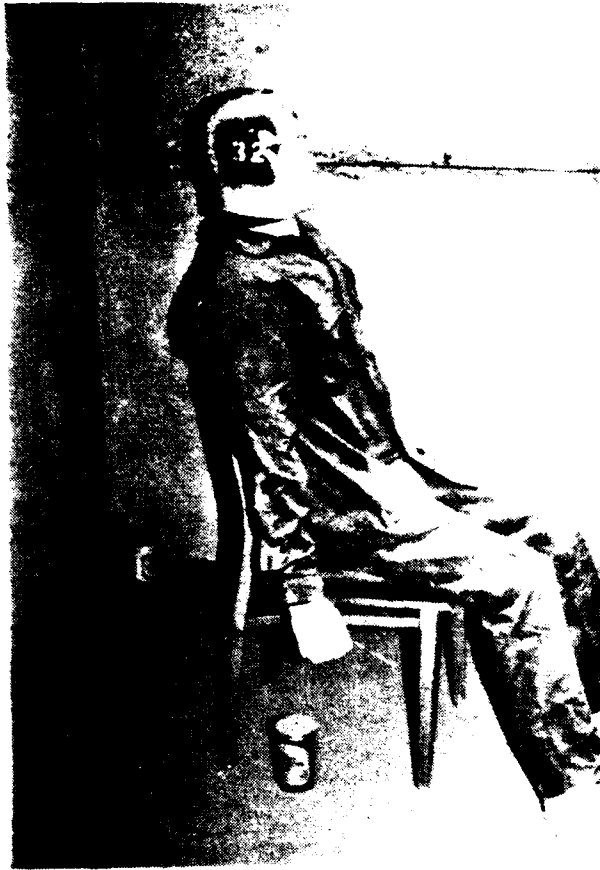
At the 20 psi ground range, the sandbags from the closure were displaced slightly, about two inches (though the displacement would have been greater for a larger weapon), and the logs were still in place. (There was no pressure gauge in this vault; the gauge originally scheduled was relocated between the two berms where one of the 5102 experiments was conducted.) The posttest environment inside the vault was similar to that in the vault at 40 psi, excepting there was a thinner layer of dust over all surfaces (Figure 6-11). No relative displacements appeared to have taken place, and there was no indication of motion of either the anthropomorphic dummy or the glass jar passive gauges. Neither were there signs of cracks or permanent deformations in the vault, despite the fact that no structural upgrading options (shores, or roof cover of expanded polystyrene) were installed.

Fig. 6-11. Posttest View of 20 psi Vault Interior.

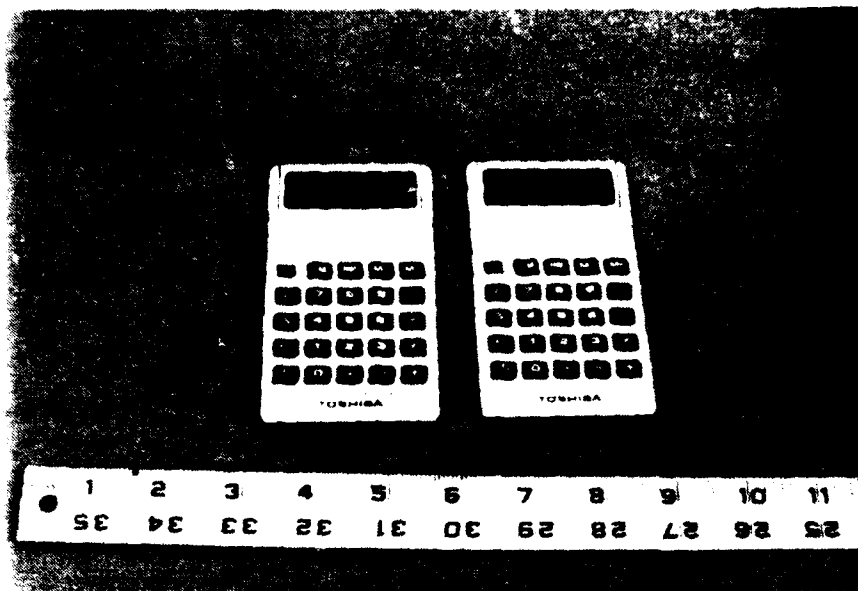
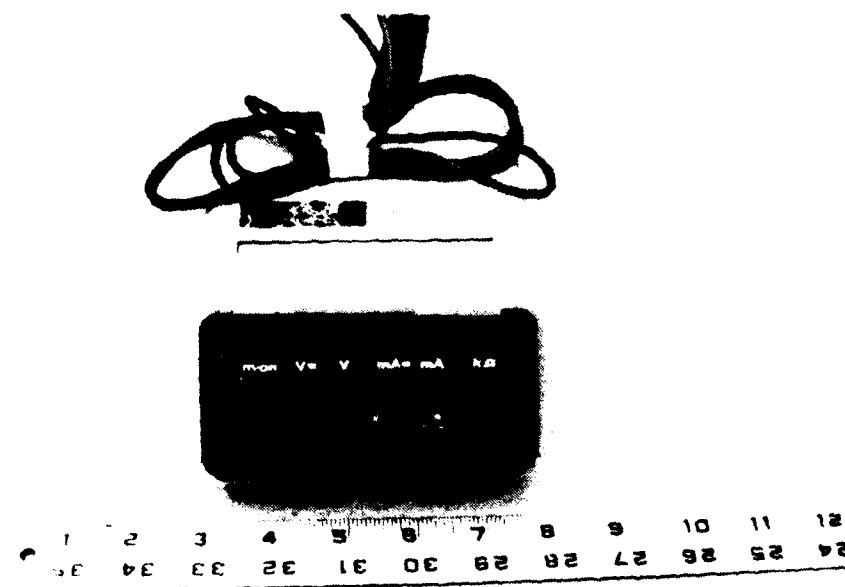
Fig. 7-16. Posttest Photographs of Electronic Equipment, Area I.

Figure 7-16 showed photographs of the calculator and the digital ohmmeter, posttest. Neither was seriously damaged and both were immediately serviceable -- principally because both were protected from missile damage, and neither package could undergo much volume change when the pressure pulse hit.

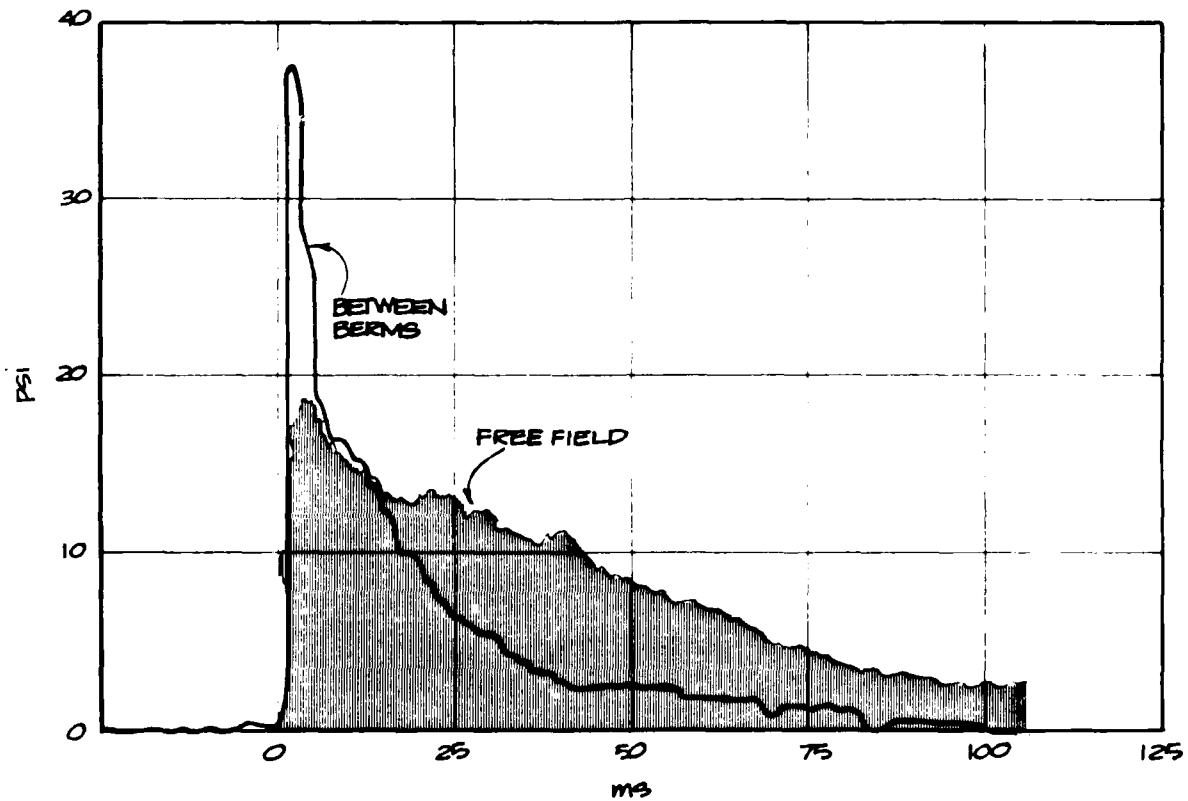
The peak overpressure recorded between the berms was a 1 to 2 ms spike, roughly twice the magnitude of the free-field overpressure (Figure 7-21). The spike was expected, the objective of the berms was not to reduce the overpressure (which is not the major problem), but rather the drag force.

Fig. 7-21. Peak Overpressure Between Berms Compared With Free-Field Overpressure.

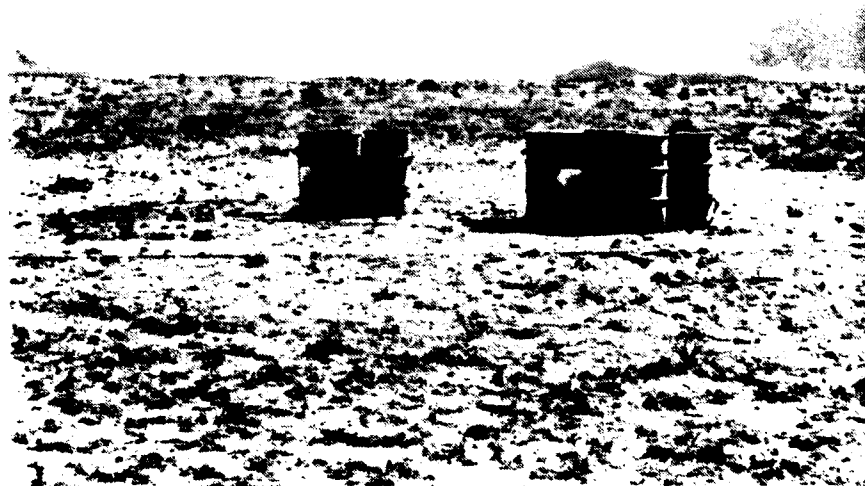
Fig. 7-27. Posttest View of Area 4.

Area 4 (5103) - On the concrete slab, the two water-filled full-scale barrel arrays retained stability and merely slid, but at the 1/10th-scale, only the seven-barrel array retained stability (Figure 7-27).

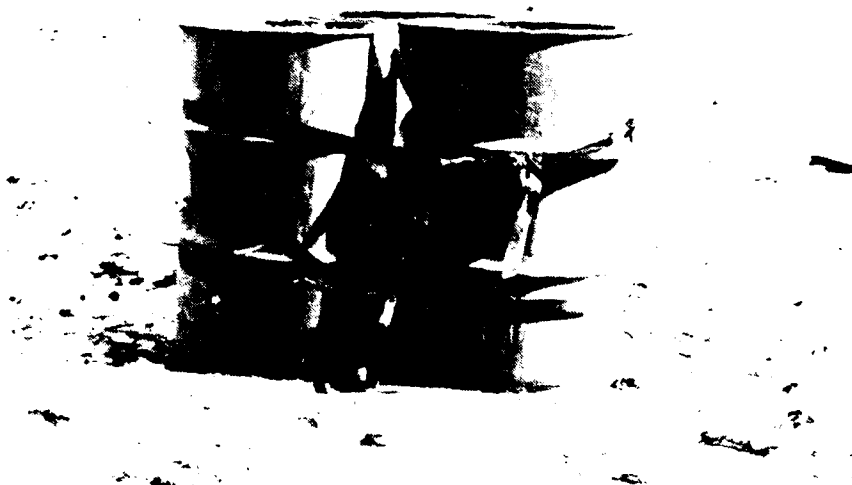
There was no single full-scale barrel on the concrete slab. The three-barrel array slid 3/4ths of an array diameter, and rotated a foot off center (Figure 7-28), but did not overturn. All the lids were blown off (Figure 7-29) and one of the drums distorted out-of-round about 2½ inches. The other two drums in this array did not distort visibly, but all three drums in the array lost 15% to 20% of the contents.

Fig. 7-29. Posttest Photograph of Three-Barrel Array, Area 4.

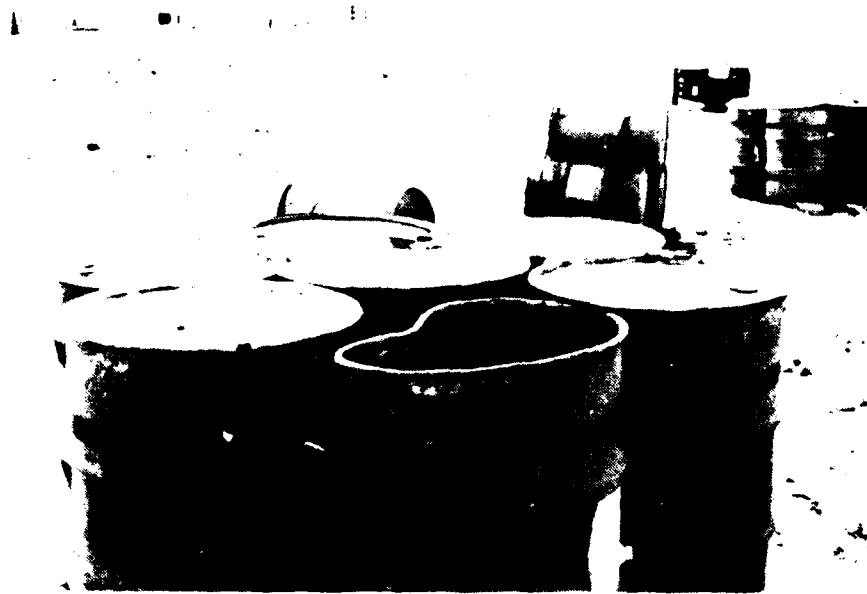
The seven-barrel array slid 1/6th of an array diameter, and rotated a foot off center. One of the barrels lost a lid and 15% of its contents, and was distorted at the top end, but the others all maintained their integrity (Figure 7-30).

Fig. 7-30. Seven-Barrel Array on Slab, Area 4, After Test.

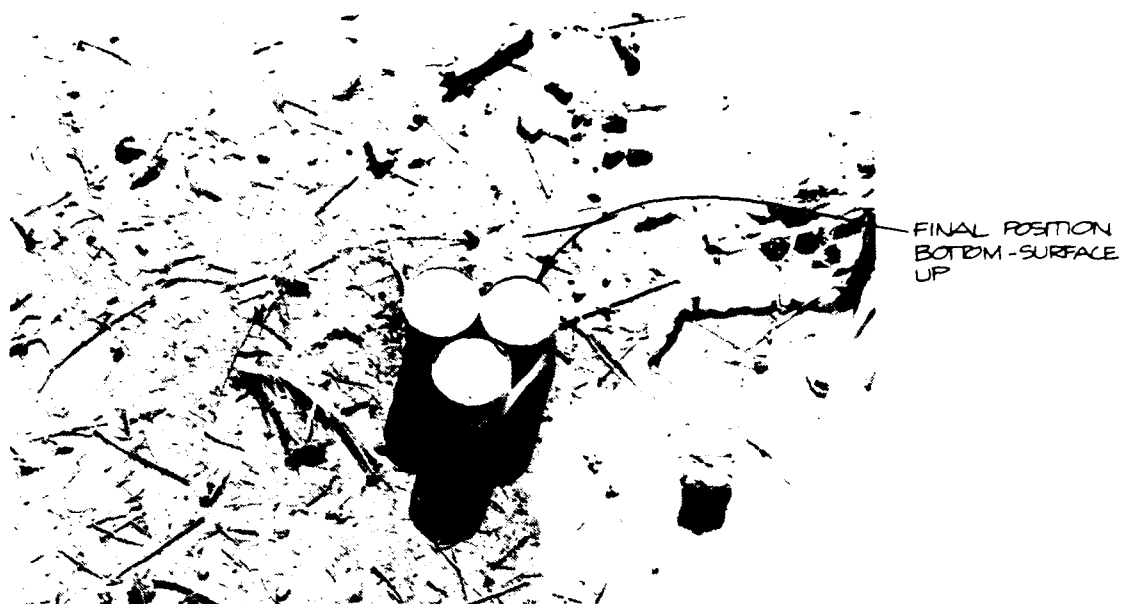
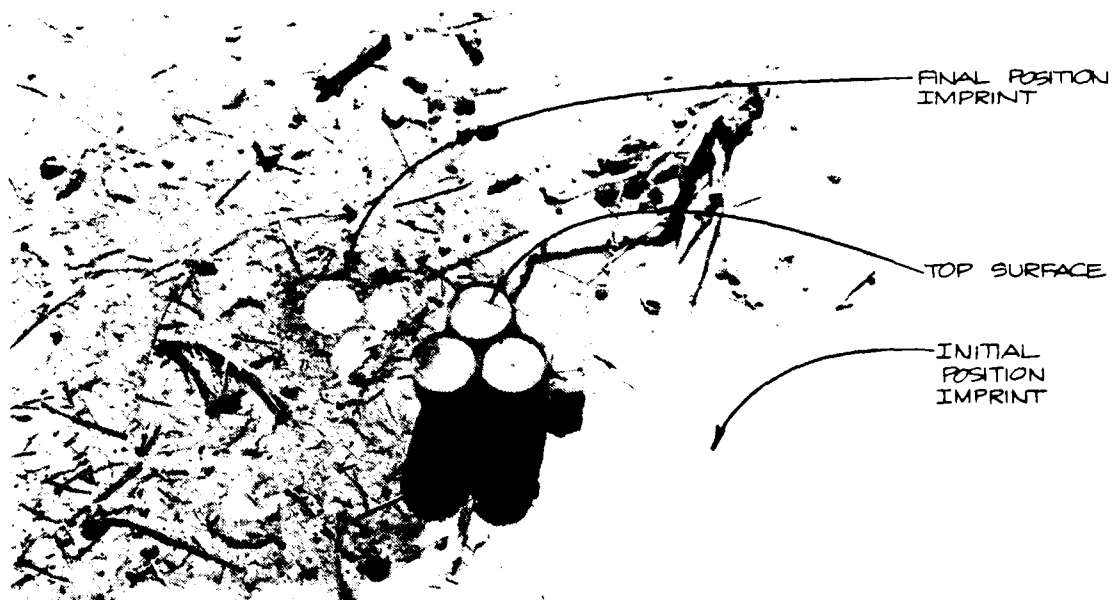
The 1/10th-scale three barrel array translated three array diameters and flipped over onto its top (Figure 7-32).

Fig. 7-32. Small-Scale Three-Barrel Array, Area 4.

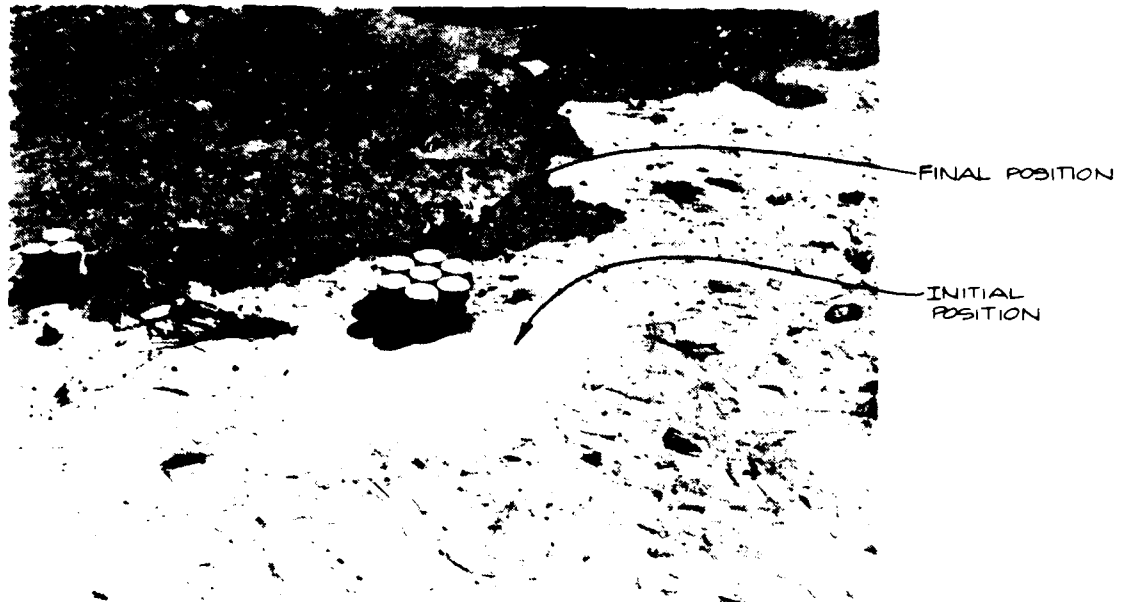
The 1/10th-scale seven barrel array slid one array diameter (Figure 7-33).

Fig. 7-33. Area 4, Tenth-Scale Seven-Barrel Array.

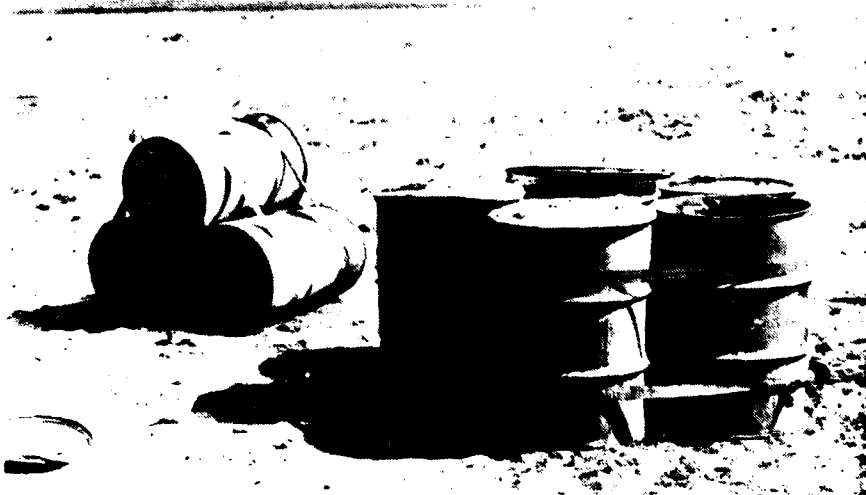
Area 5 (5103) - In the area where the soil was graded level, the ten water-filled drums in the group that duplicated the three- and seven-barrel arrays in Area 3 also duplicated the response observed in Area 3 (Figure 7-34). Most of the eleven-barrel group that had been partially filled with water suffered from crushing, and the lids and half or more of the contents were missing (Figure 7-35). The two band saws protected by the lumber package were undamaged and immediately

Fig. 7-34. Area 5, Three- and Seven-Barrel Arrays After Test.

The seven-barrel array visible in Figure 7-34 translated a total distance of one-third of a foot in the direction of the blast wave. Two lids came off altogether and one was partially lifted off, but there was little distortion in any of the drums. The lidless drum clearly visible in the figure lost 40% of its contents and the other lidless drum lost 25% of its contents, not unlike the events in Area 3.

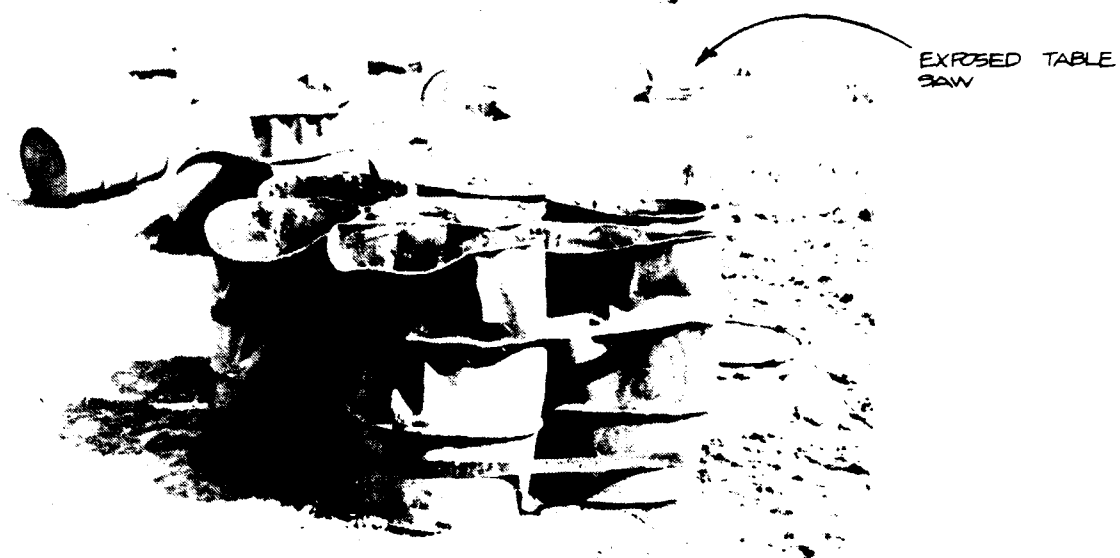
Fig. 7-35. Posttest Photograph of Partially Filled Barrels, Area 5.

The seven-barrel array translated one half a foot. Five of the seven barrels lost their lids and half their contents (leaving them about 1/4th full) and these barrels were severely crushed. The center barrel, which retained its lid and contents, was sufficiently protected that it was not crushed. And the remaining barrel that retained its lid and contents was crushed at the top, by the tension in the webbing that crossed it there (Figure 7-35).

The table saw that was located in the free field was translated 25 ft downstream and overturned (see Figure 7-35), but only the on/off switch was damaged - apparently because this saw did not impact at any time on the vulnerable mounting appendage for the safety fence. The switch was readily repaired, and the saw was operable in a matter of minutes.

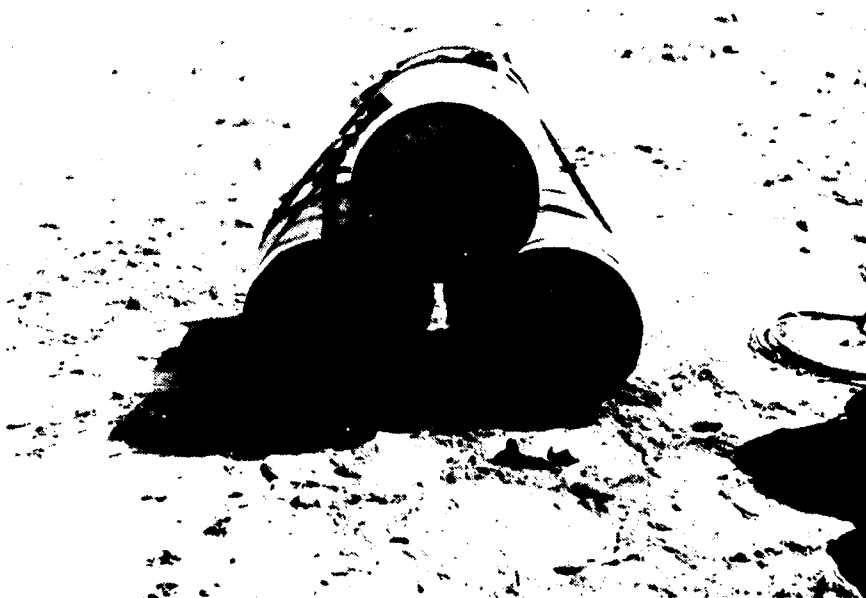
Fig. 7-36. Posttest Photograph of Three-Barrel Array, Area 5.

There was no single barrel in the ten-barrel group of water-filled drums. The three-barrel array translated a total distance of 4 ft (one array diameter) and overturned. The lid came off one of these drums, the one on the bottom right side of the array (Figure 7-36), and all the fluid spilled, but the other two drums maintained their integrity and contents. The results essentially duplicated those in Area 3.

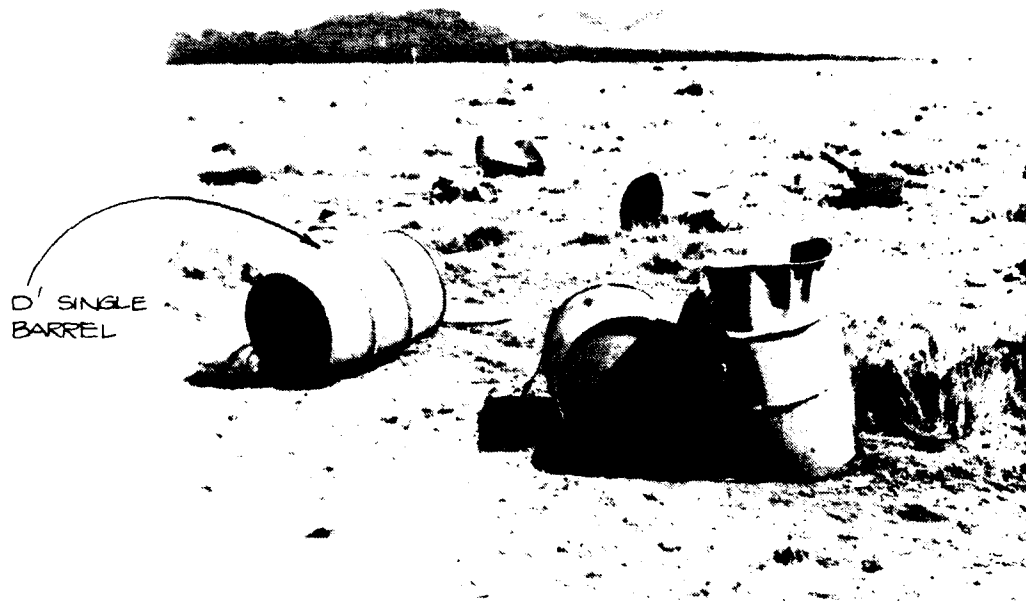
Among the barrels in the group that was partially filled, the single barrel translated about the same total distance as the single barrels that were completely full, i.e., 4 ft, and it also overturned. In addition, it lost both its lid and contents and became slightly crushed in the middle, but not at the ends (the barrel marked D' in Figure 7-37).

Fig. 7-37. Area 5, Partially Filled Barrels After Test.

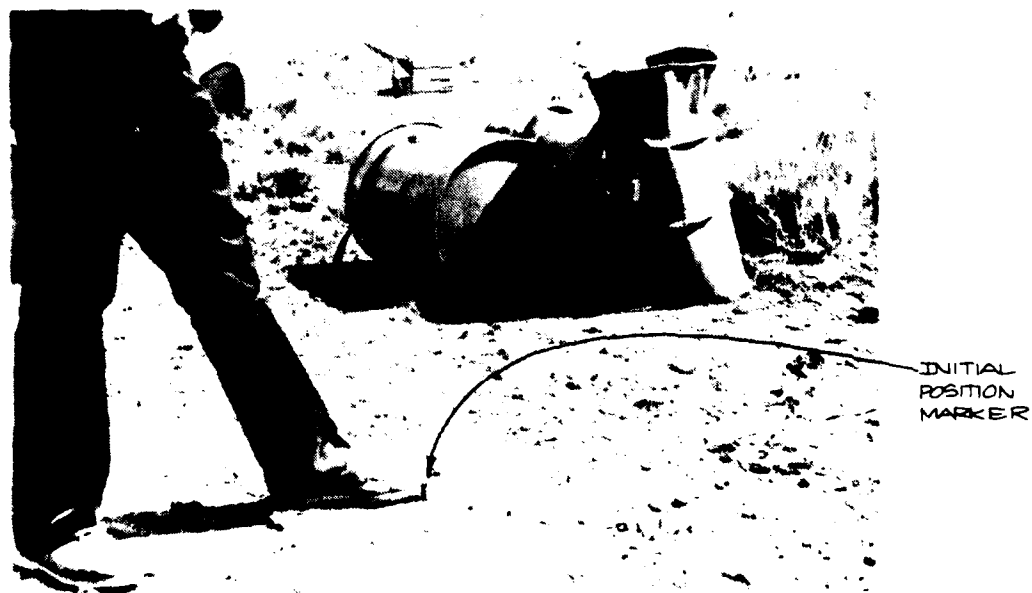
The three-barrel array in this group translated a total distance of six feet (Figure 7-38 - which also shows the benchmark that indicates the array's initial position), and the array came apart. Two of the drums were overturned but maintained their integrity and contents, while one of the drums lost its lid and most of its contents and was severely distorted, but remained upright.

Fig. 7-38. Area 5, Three-Barrel Array After Test.

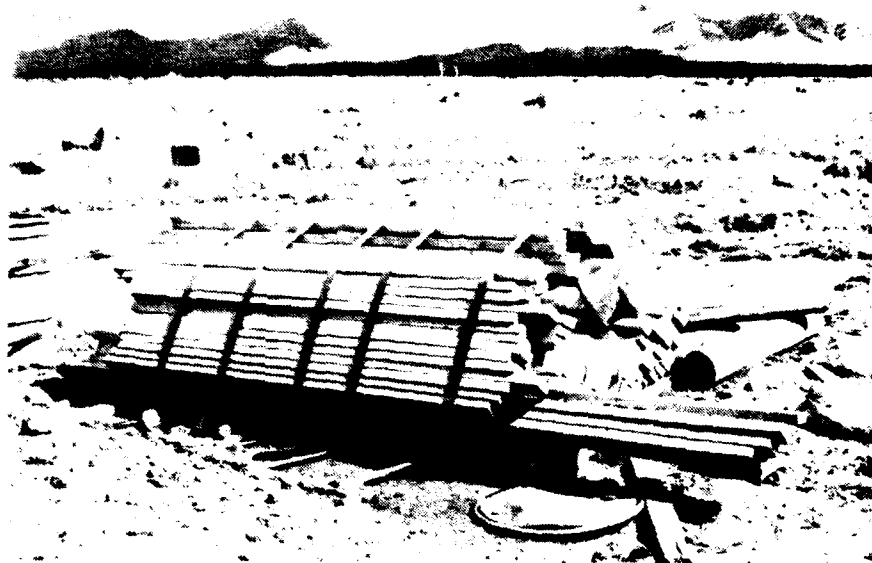
The lumber stack used to protect two band saws was partially overturned (Figure 7-39), but maintained its integrity and remained anchored. Partial overturning occurred because only the bottom half of the package was stabilized by logs piled behind it. The total load on the package, which was oriented to provide the maximum drag, was slightly over 30,000 pounds. Thus, the load per anchor and the tension in the webbing corresponded to, roughly, 5,000 pounds. The effects of this tension can be seen in Figure 7-40 where the webbing cut into the lumber along the junction of the bottom and front faces of the package. The band saws recovered from inside the package suffered no apparent damage and were immediately operable.

Fig. 7-39. Area 5, Lumber-Protected Equipment Package After Test.

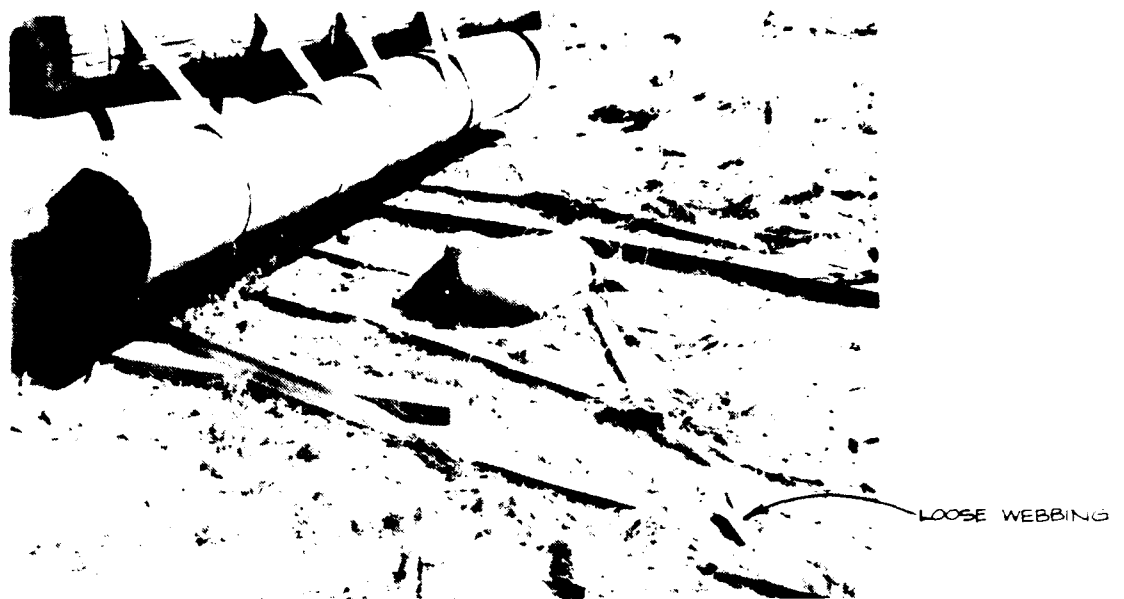
The stack of logs packaged and anchored so as to be exposed end-on to the blast with the anchoring force at right angles to it (Figure 7-15) remained anchored, but there was some minor rearrangement of the logs (Figure 7-44). It appears the lead expedient anchor was pulled loose (Figure 7-45, right-hand bottom corner, and center foreground in Figure 7-46).

Fig. 7-45. Closeup Photograph of Log Package Anchoring.
